Manhole Inspection Summary

Manhole # S23MM1044MH

Location Address: **4501 DEER RIDGE DR** Cross Street: **COLD SPRING LN**

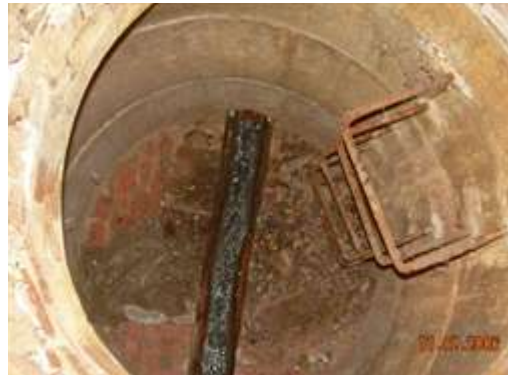
Top View

Barrel infiltration. Corroded steps.
Evidence of surcharge - Bench debris.

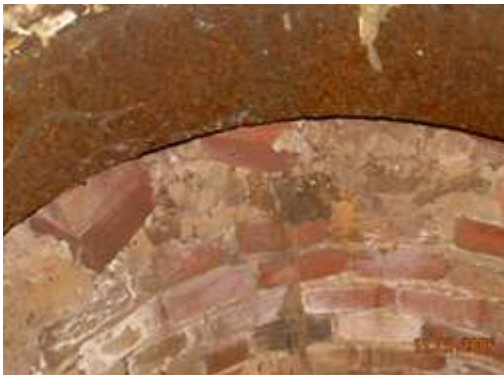
Defect

Frame leaks. Adjustment deterioration
and infiltration.

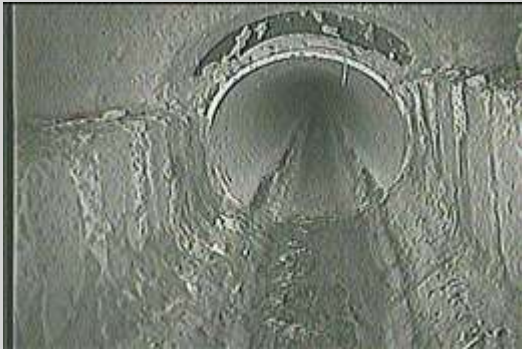
Pipe Out @ 12 O'Clock

Pipe Material: **PVC**

☒ Pipe Lined

Invert Depth: **9.65** (ft.) Flow Characteristics: **Slow**

Infiltration: **None**

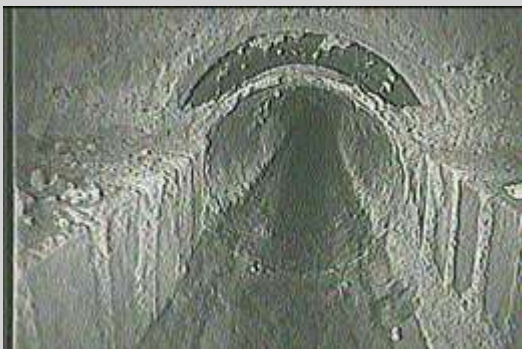
Pipe In @ 6 O'Clock

Pipe Material: **PVC**

Invert Depth: **9.50** (ft.) Flow Characteristics: **Slow**

Infiltration: **None**

Connects To: **Dead End**
